# Manhole Inspection Summary

Manhole # S11CC\_014MH

Insp Date: **7/9/08 3:23 PM**

**Location** Address: **1212 LONGWOOD ST**

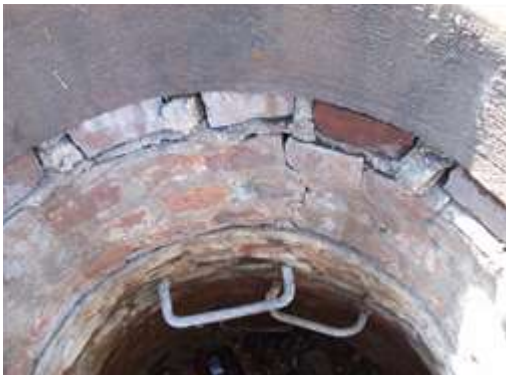
Defect 1

Condition: ☐ Sound ☒ **Cracked** ☐ Root Intrusion ☒ **Loose Brick** ☐ Deteriorated

CRACKED CHIMNEY, LOOSE BRICKS

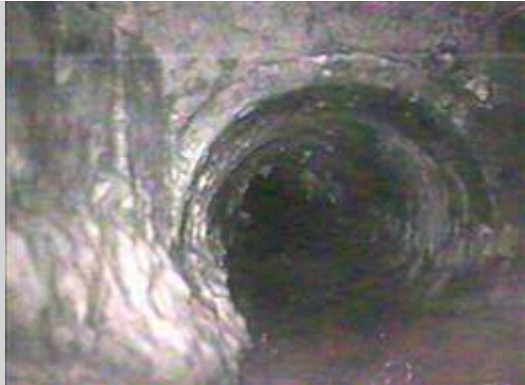
12 O'Clock Outflow

8 in. Circular Gravity Sewer  
Pipe Out @ 12 O'Clock

Pipe Height: (in.) Direct  
Pipe Material: **Clay** ☐ Pipe Lined  
Invert Depth: **8.02** (ft.) Flow Characteristics: **Fast**  
Deposits: ☐ None ☐ Mud ☒ **Sludge** ☐ Debris ☐ Grease  
Silt Depth: **1** (in.) Deposits Extent: **Light**  
Infiltration: **None** Pipe Seal Cond: **Sound**

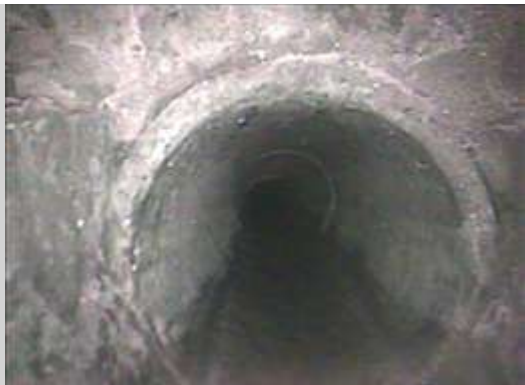
3 O'Clock Inflow

8 in. Circular Gravity Sewer  
Pipe In @ 3 O'Clock

Pipe Height: (in.) Direct  
Pipe Material: **Clay** ☐ Pipe Lined  
Invert Depth: **7.75** (ft.) Flow Characteristics: **Fast**  
Deposits: ☒ **None** ☐ Mud ☐ Sludge ☐ Debris ☐ Grease  
Silt Depth: (in.) Deposits Extent:  
Infiltration: **None** Pipe Seal Cond: **Sound**

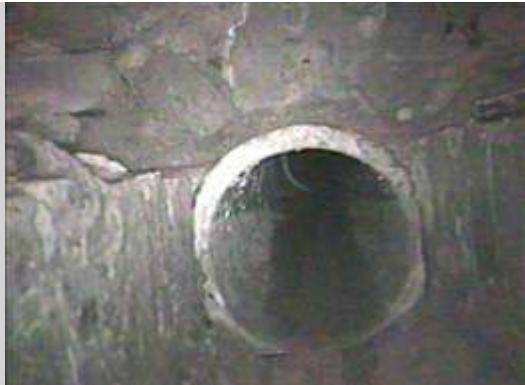
6 O'Clock Inflow

6 in. Circular Gravity Sewer

Pipe In @ 6 O'Clock

Invert Depth: **7.62** (ft.) Flow Characteristics: **None**

Deposits: ☒ None ☐ Mud ☐ Sludge ☐ Debris ☐ Grease

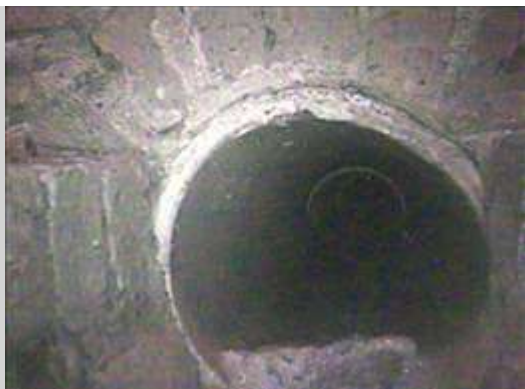
9 O'Clock Inflow

8 in. Circular Gravity Sewer

Pipe In @ 9 O'Clock

Invert Depth: **7.71** (ft.) Flow Characteristics: **Slow**

Deposits: ☒ None ☐ Mud ☐ Sludge ☐ Debris ☐ Grease
